"Improving irrigation in the Australian cotton industry"

GWYDIR VALLEY
IRRIGATORS ASSOCIATION
 INCORPORATED

Bankless Channel

Bankless Channel / K29:

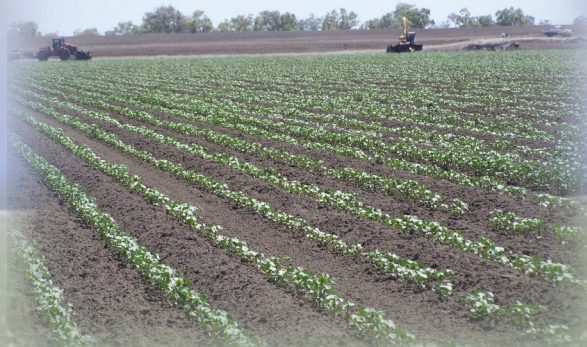
Germination of bankless channel field.
