RRDPI730 Technical Research Report
30th July 2018

Smarter Irrigation Grower-led Cotton Automation Integration Trial

Gwydir Valley Irrigators Association Inc

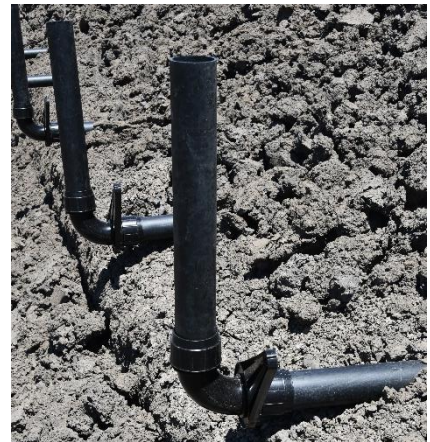
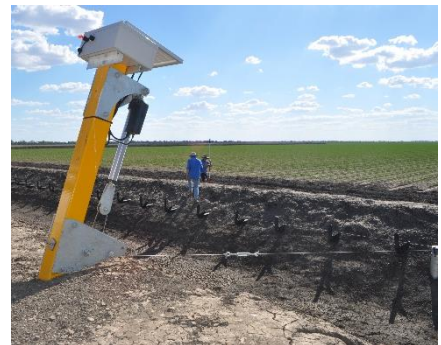
Figure 1: K28 layout and gang design

The K28 field has variable row length from 418 to 868 meters and a 1,650 meter head ditch length. The field was divided into eleven groups or gangs of siphons. Five gangs had between 120 and 150 siphons, while the remaining six had between 71 and 77 siphon. The smaller gangs were necessary as they operated at a higher channel head than the other gangs. As the actuation force and tension on the cable is proportional to both the number of siphons and the channel head, it was necessary to reduce the number of siphons in these gangs, so that they could be easily turned on and off without putting too much pressure on the components. Each of the gangs was connected with a steel cable to a control box mounted on a post. The control boxes were fitted with remote terminal units, actuators and wireless modems. The remote modems were specifically designed to control the siphons via a mobile app and were not fitted until February 2018.

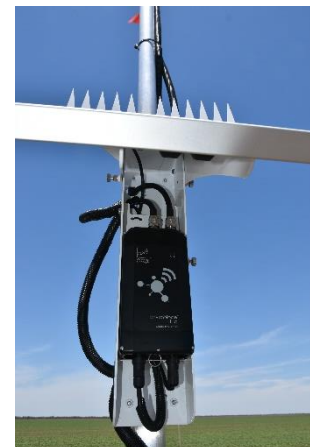
The telemetry and management system were managed with an EnviroNode Hub. The hub gathered data from water level sensors and enabled the control of the Smart Siphons remotely. The EnviroNode Hub is a versatile, rugged and reliable product platform developed for customisation. It is a standalone device that can simply be bolted to a mast and connected to a solar panel. It has a solar charged internal lithium ion battery and is environmentally protected to IP67. All communications, data management and control functionality are inbuilt.

The Wireless Water Level Sensors are ultrasonic with a distance measurement range of approximately 20cm to 750cm and a resolution of +/-1cm. The sensors were supplied in an IP67 protective enclosure, mounted vertically with clear space below them.

An important component of the progress towards automation of the siphon field involved the investment in channel level sensors. The ultrasonic equipment was installed in the head ditch of K28. This equipment measures the water level in the head ditch. Information from the sensor was readily available on the customised mobile device web app developed for the project. The irrigation team at Keytah found that this worked extremely well providing real time information enabling more accurate monitoring of head height and hence flow rates. The critical nature of this information and the importance of real time access reaffirms the need for effective telecommunications on farm.

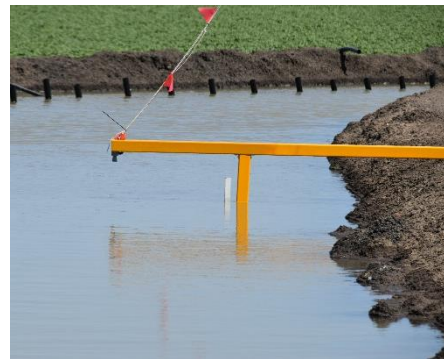
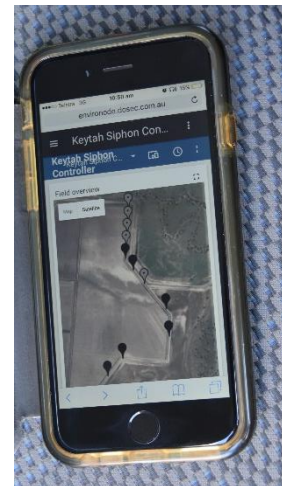
¹ Summary of field measurements

In field flow meters were installed in gang 1B, 5 and 6, flow volume and rate were collected from these devices. In addition, Irrimate measures were taken from gang 6 during the season to measure water advance down the field. IrriMATE advance meters were installed in the eight consecutive furrows being supplied from pipes numbered 17 to 24 in gang 6. The fifth advance sensor coincided with the position of the flowmeter. In the advance data furrows one and three were wheeled furrows and the remaining furrows non-wheeled furrows. Advance sensors were installed at five distances along the length of these furrows. The positions of these sensors were measured using a GPS at zero meters, 191m, 394m, 591m and 830m from the start of the crop at the head ditch end of the field. The tail drain end of the field was at 860m.

During the irrigation event on the 22nd December 2017 the flow rates recorded were; 5.198 L/s (flowmeter) or 5.322 L/s (water level over mean pipe RL). There was no significant change in flow rate over time, so a constant flowrate was used in SISCO. For the following irrigation on the 5th of January the flow meter failed mid irrigation, using the water level over the mean pipe RL the flow rate was measure at 4.95L/s. During this irrigation the channel water level increased with time resulting in a variable flowrate. SISCO was used to analyse the data which is available in the Summary of field measurements¹.

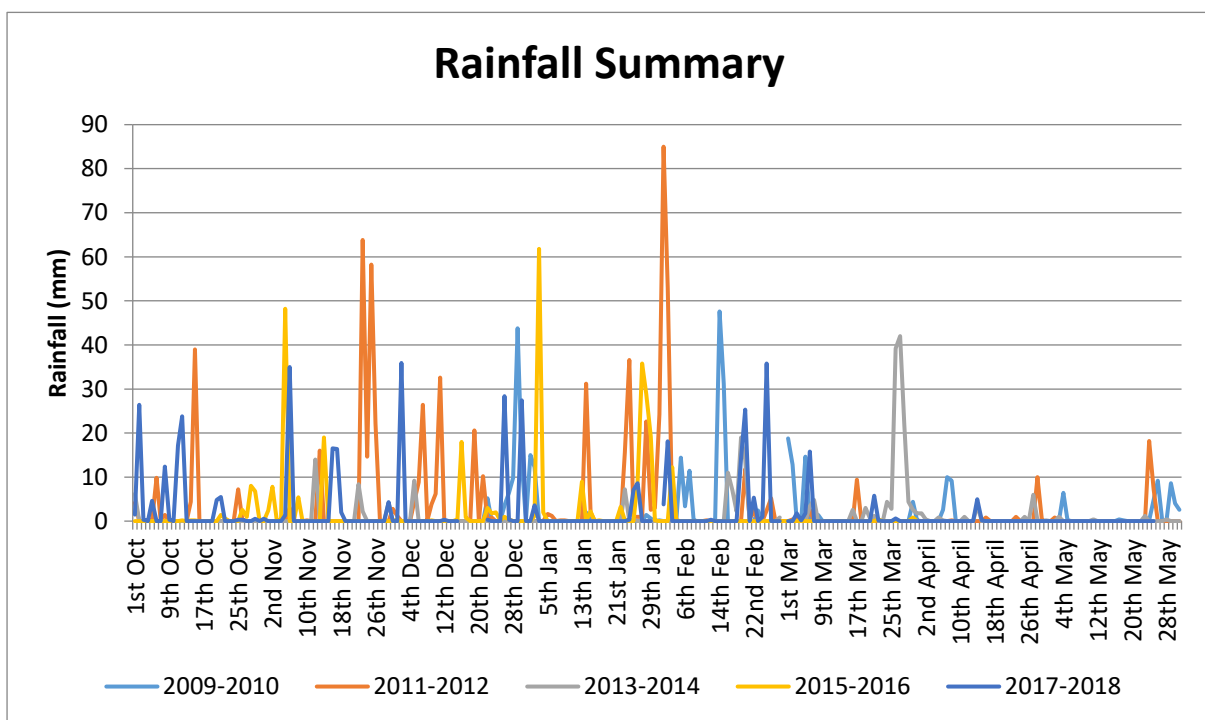
Figure 2: Rainfall

The trial site received a total of 421mm of rainfall from October 2017 to May 2018. The daily rainfall data (figure 2), indicates that there were 12 effective rainfall events during the season where more than 10mm of rain was received (88% effective rainfall).

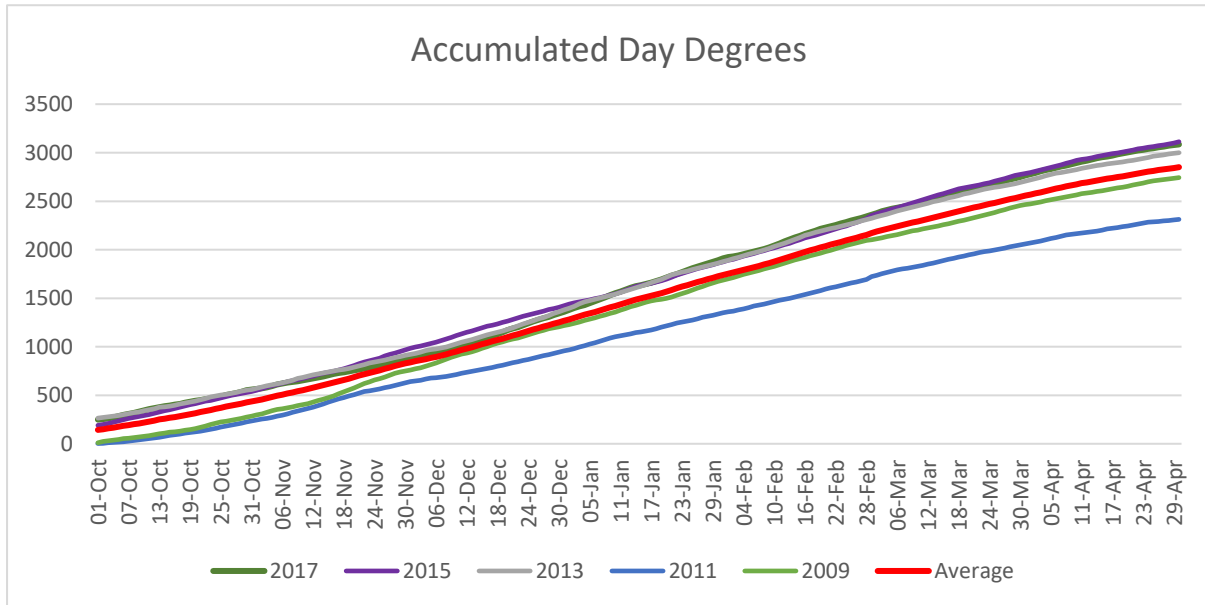
Figure 3: Accumulative Day Degrees

The accumulated day degree which was slightly above the long-term average as shown in figure 3.

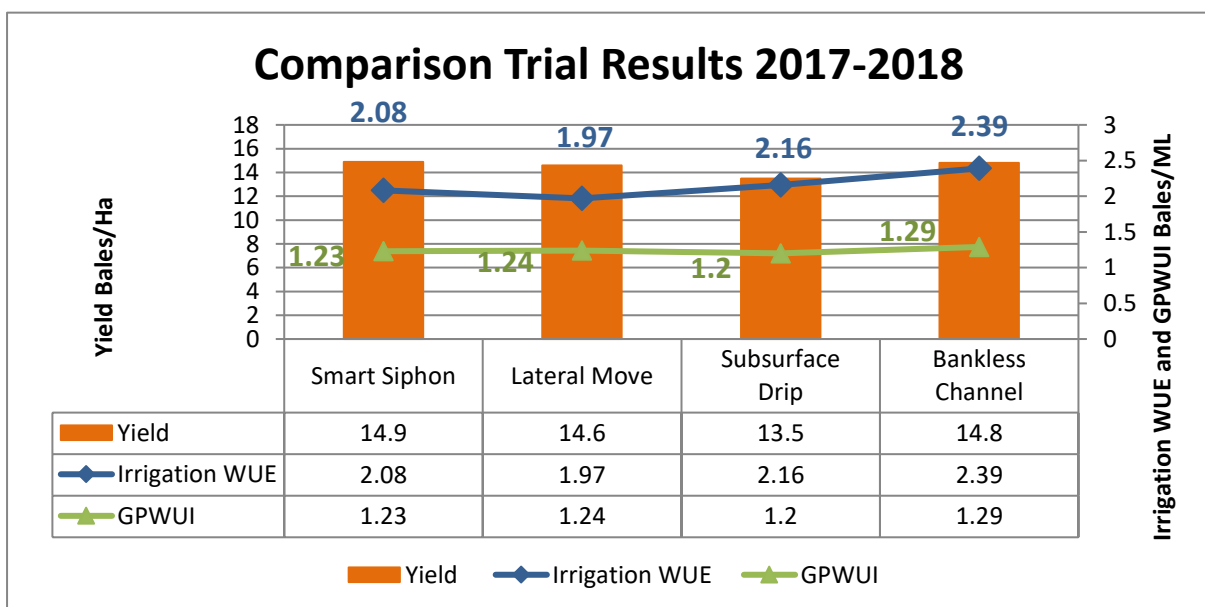
Figure 4: Yield (module estimates) and Water Use Efficiency 2017-2018

The performance of all four systems was better from a yield perspective in the 2017-2018 season than in the previous seasons. A summary of the yield, irrigation water use index and Gross Production Water Use Index (GPWUI) is shown in figure 4.

The irrigation water use index is calculated using area grown, bales produced, and total irrigation water applied. The GPWUI is however a more realistic index to make comparisons between systems and between seasons as in addition to area, yield and irrigation water, it considers the used soil reserves and the in season rainfall. The higher the GPWUI the more efficiency the performance.

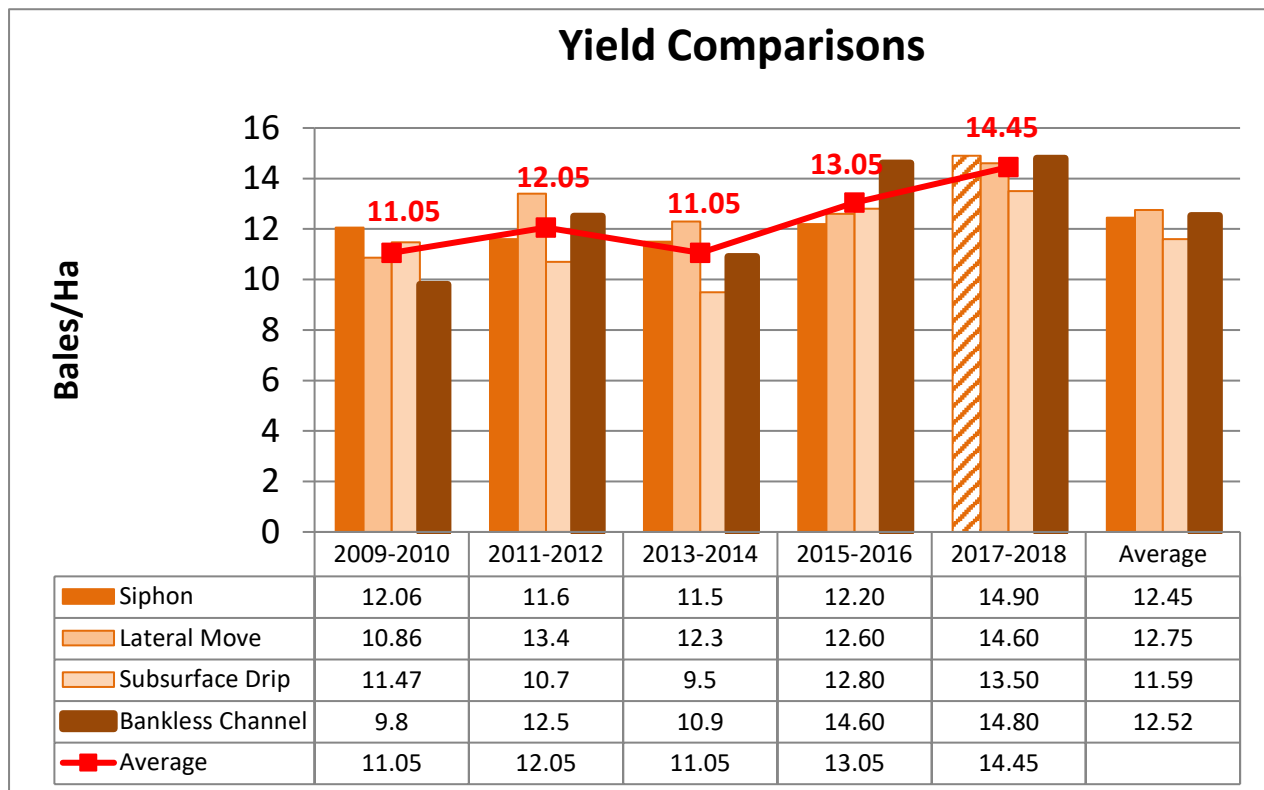
Figure 5: Yield Comparison over five seasons

Figure 5 combines the yield data for the five years of the trial. The graph shows that the highest yields for each of the systems were achieved in 2017-2018. There was an average 10% increase in yield in 2017-2018 compared to 2015-2016, which highlights that the 2017-2018 was a good season.

The graph shows that there is more yield variation between seasons than there is between systems. This however is less than the variation seen in water use efficiency and GPWUI between seasons (figure 6).

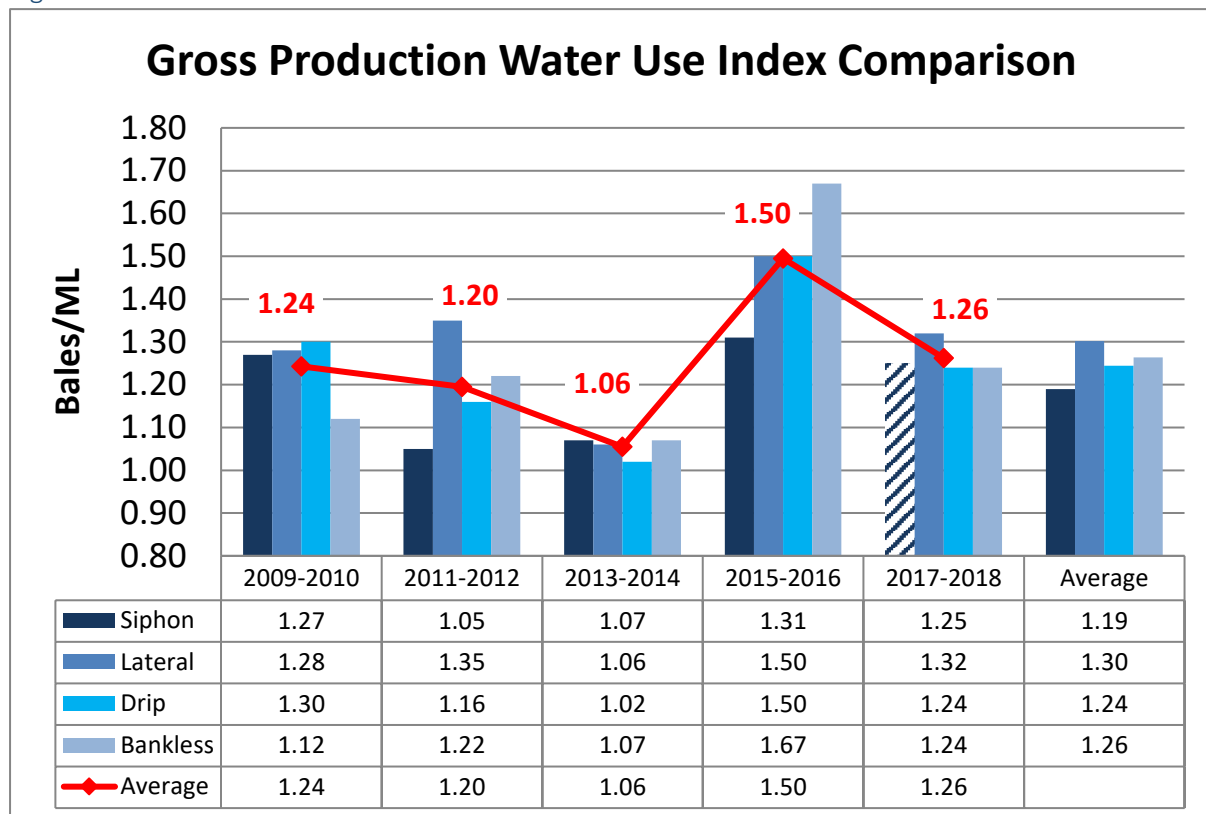
Figure 6: Gross Production Water Use Index

The Average GPWUI for 2017-2018 was 1.26 bales per megalitre. The average GPWUI over the five seasons studies varied from 1.06 bales per megalitre in 2013-2014, a warm to hot season with almost no rainfall, to 1.50 bales per megalitre in 2015-2016, a more typical season. There were similar trends in the individual systems over each of the seasons. Variation between seasons have been found to be greater than the variation between systems. It is important to note that in 2011-2012 the siphon field was more dramatically impacted by the two flood events which caused water logging as the flood water could not be drained from the siphon field as quickly as necessary. This may have caused the low GPWUI for the siphon field in that season. The poor establishment of the bankless channel field in 2009-2010 may also have impacted the GPWUI for that year.

As with the yield comparisons, over the five trial seasons it is possible to see trends in GPWUI which are most probably due to the climatic conditions. The average GPWUI across all systems for 2009-2010, 1.24 bales per mega litre, and 2017-2018, 1.26 bales per mega litre, both were reasonably

The average GPWUI drops significantly to 1.06 bales per mega litre, in the hot dry 2013 – 2014 season which is not surprising given the temperatures and the lack of rainfall, all systems were pushed to their limits. The much higher GPWUI in 2015 – 2016 (1.50 bales per mega litre) when irrigation water was tight is less easily explained but may be a result of the crop using more of the soil moisture reserves than in the other years of the trial.

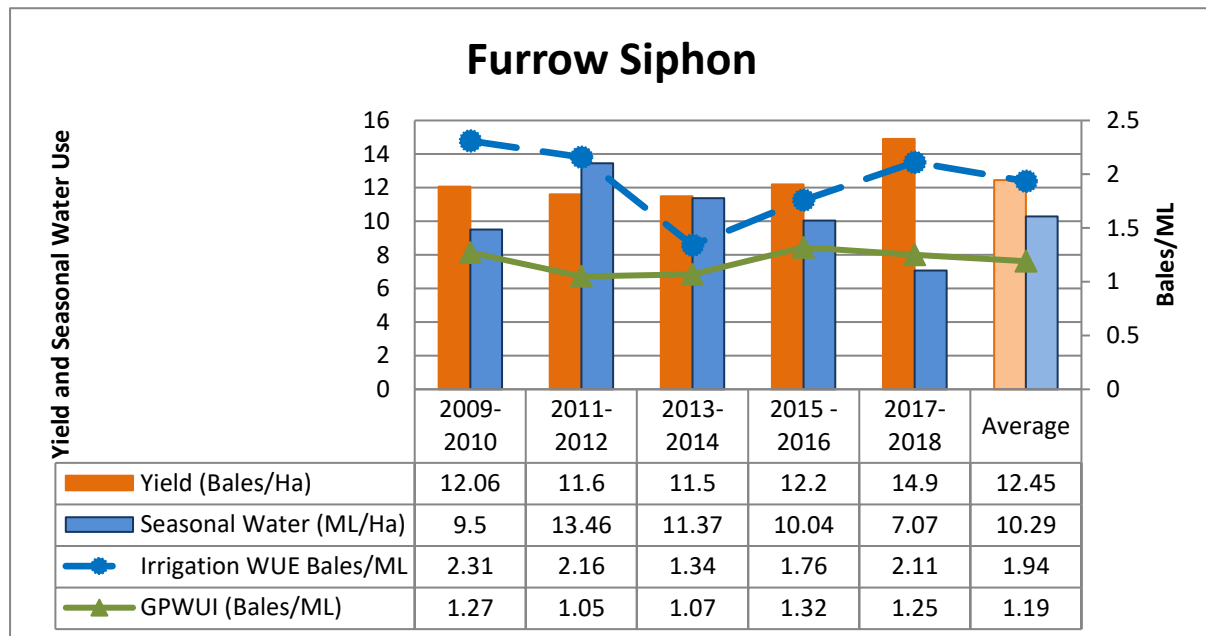
Figure 7: Furrow Siphon System

with the bankless system) in the hot dry 2013-2014 season. In the 2017-2018 season the GPWUI was very similar to the bankless channel and the drip systems. This season produced the highest yield and lowest seasonal water use of the five seasons. The yield was noticeably more than in previous seasons.

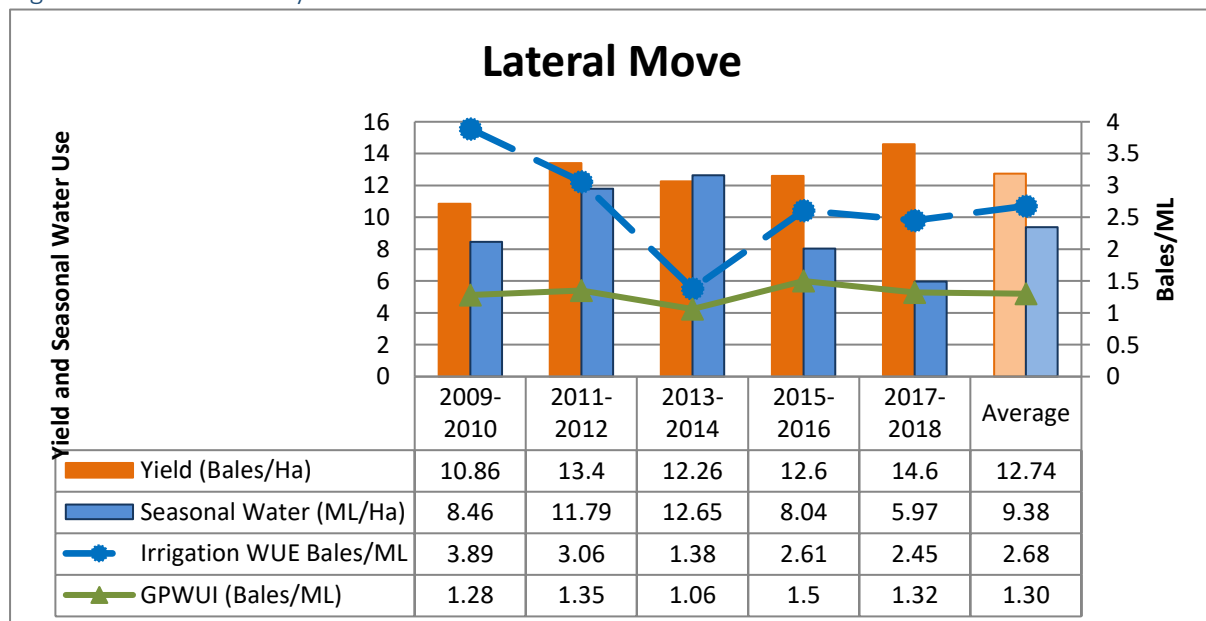
Figure 8: Lateral Move System

The lateral move results shown in figure 8 below demonstrate that this system has the potential to produce the highest average yield, irrigation water use efficiency and GPWUI. The lateral produced the highest average yield of 12.74 bales per hectare, an irrigation water use efficiency of 2.68 bales per mega litre and a GPWUI of 1.30 bales per mega litre. Better than the other three systems.

The results do however show quite an amount of seasonal variation. Figure 8 suggest that in a hot dry season as seen in 2013-2014 that the GPWUI for the lateral system has the potential to be compromised, as irrigators strived to maintain sufficient water to the crop. In contrast the lateral system is well suited to wet seasons (2011-2012) where there were two flood events and a large number of cloudy days. It is easier to manage irrigation volumes with this system under these conditions, minimising the potential for water logging despite the flooding. Whilst in the hot seasons there is constant pressure to maintain irrigation, any breakdown in such conditions could have very dramatic consequences.

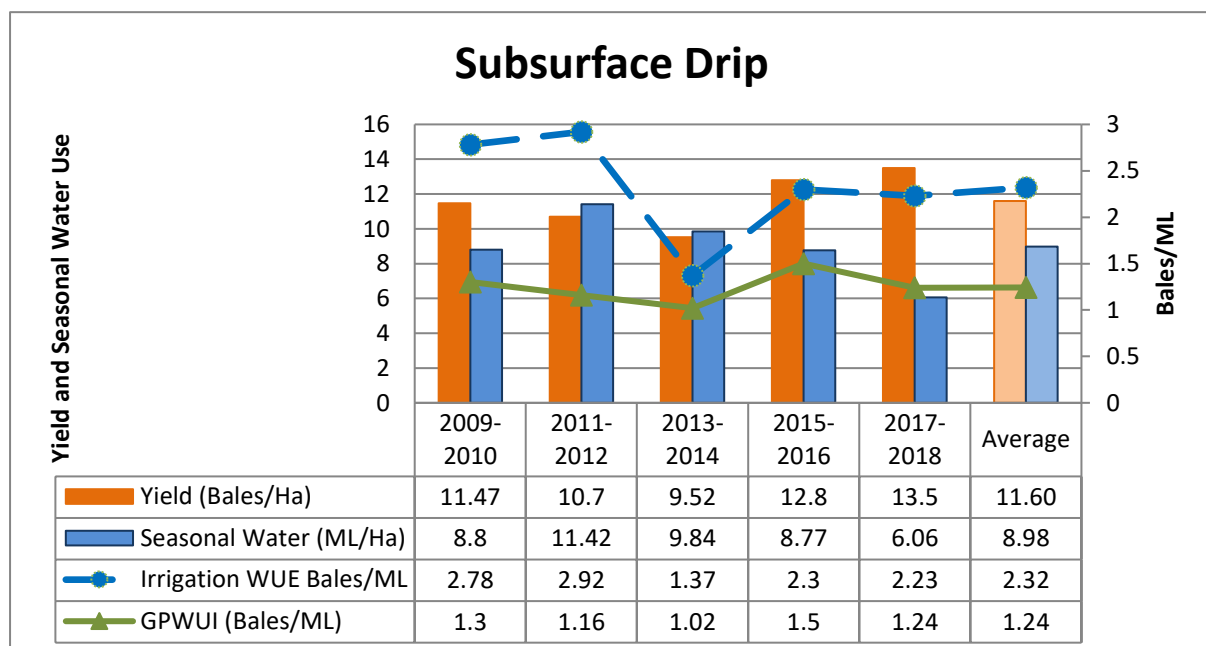
Figure 9: Subsurface Drip System

Figure 9 following shows the five years of results for the subsurface drip system. During the five years of the trial it has struggled to produce consistency in yield but has achieved good irrigation water use efficiency results. The average yield of 11.6 bales per hectare is 0.86 of a bale behind the other systems. The performance of the drip was expected to be stronger in the wet 2011-2012 season, but there was some difficulty in removing runoff following several heavy rain events. This caused some waterlogging which may have affected the result. The hot conditions in 2013-2014 impacted the efficiency of the drip system. It was difficult to maintain sufficient irrigation water to the crop during the hot weather.

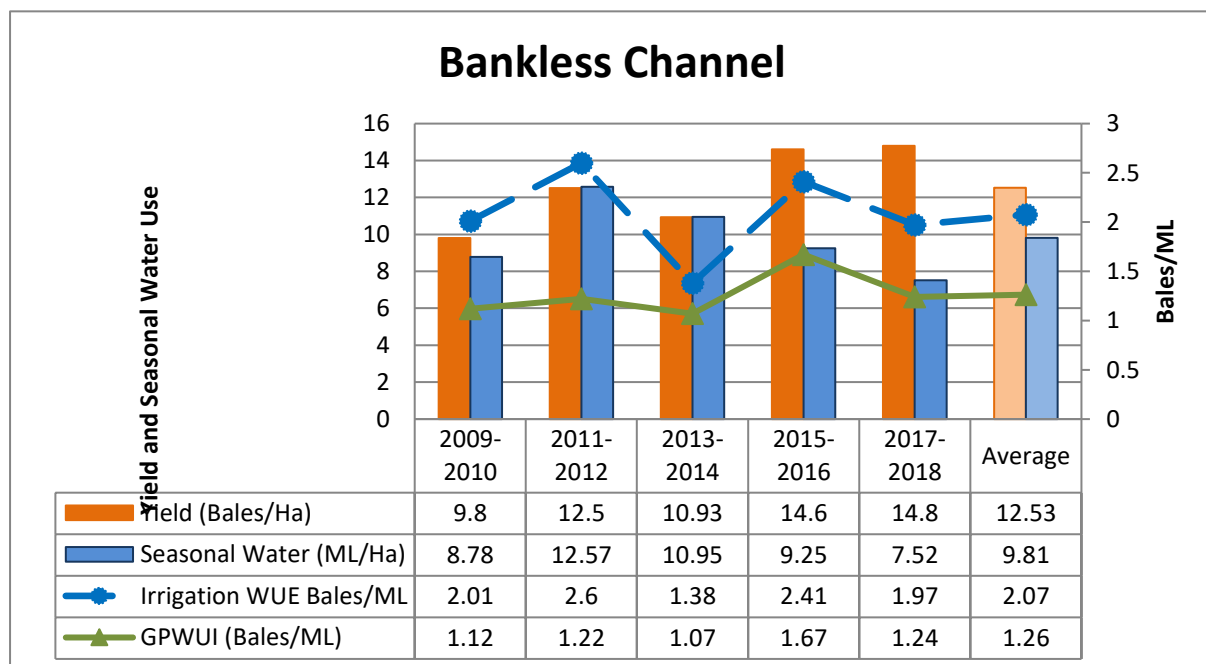
Figure 10: Bankless Channel System

The bankless channel system results over five seasons (figure 10) demonstrates that this system shows considerable promise. The bankless channel has produced the highest yield in the last two seasons 2015-2016 and 2017-2018, and the highest GPWUI in both 2013-2014 and 2015-2016. Unlike the siphon and drip fields the bankless system does not seem to have been impacted by any water logging in the wet 2011-2012 season, possibly as the water could be drained quickly from the field. The bankless channel design appears to be suited to the hotter conditions as demonstrated by the GPWUI of 1.07 bales per megalitre in the hot dry 2013-2014 season.
